North American Society for Trenchless Technology (NASTT)  
NASTT's 2013 No-Dig Show

Paper TM1-T5-05

## Advanced Condition Assessments: The Benefits of Using Pipe Penetrating Radar

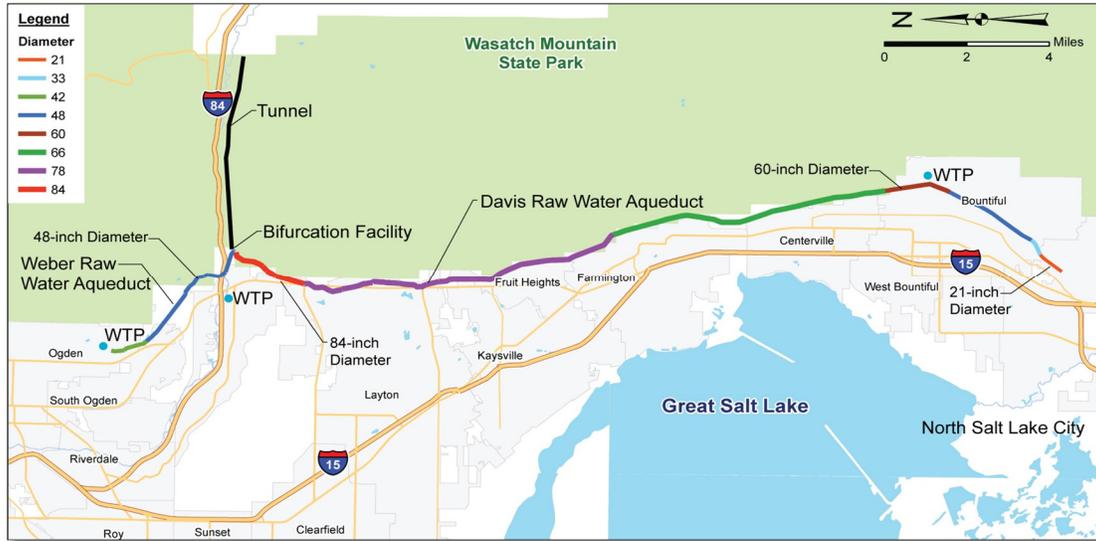
The U.S. Bureau of Reclamation (BOR) began planning the Weber Basin Project in 1942, and Congressional authorization was received in 1949. The Weber Basin Water Conservancy District (WBWCD) was created on June 26, 1950, by a decree of the Second District Court of Utah, under the guidelines of the Utah Water Conservancy Act. The District was formed to act as the local sponsor of the federal project and to supply water resources to the population within its boundaries. The original project, including reservoirs, canals, aqueducts, irrigation and drainage system and power plants were constructed by the BOR from 1952 to 1969. The WBWCD covers over 2,500 square miles within five counties near Salt Lake City, UT: Davis, Weber, Morgan, Summit, and part of Box Elder. In total, WBWCD delivers approximately 220,000 acre-feet of water annually. The project included two aqueducts (Weber and Davis) consisting of 26 miles of 21 to 84-in. reinforced concrete pipe, mortar coated and lined steel pipe, and modified prestressed concrete cylinder or bar wrapped pipe all of which were constructed in the early 1950s. See Figure 6.

**Figure 6: WBWCD’s Raw Water Aqueduct System.**

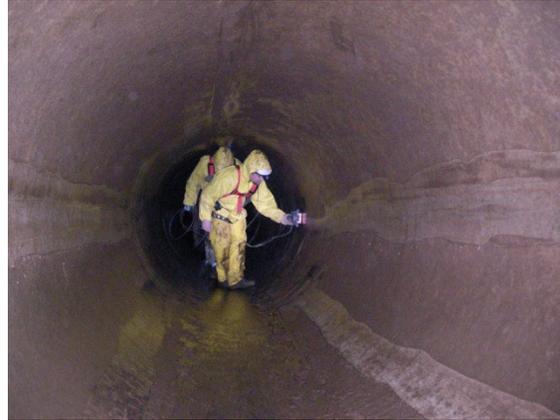
The effective 2D data acquisition is illustrated in Figure 7. The red lines show the circumferential lines that were collected every 2-in. (5 cm) from the joint in both directions. The green lines show the horizontal lines collected at 3, 6, 9, and 12 o’clock positions. During data processing the circumferential lines were merged with the longitudinal lines and were processed as grid data.

**Figure 7. Circumferential and Longitudinal Lines at a Joint (left) and Scanning Longitudinal Lines (right).**

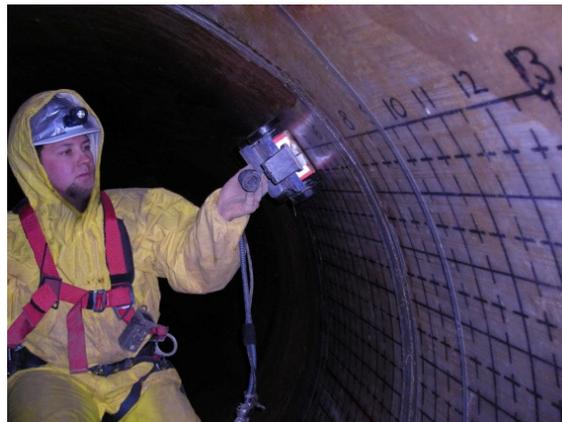
A securely fixed 48" by 48" PPR grid covering approximately one quadrant of the pipe was placed at the bottom of the pipe. Line spacing was 2" in each direction. The effective 3D data acquisition is illustrated in Figure 8.

**Figure 8. Position of High-Resolution Grid Measurements (left) and High-Resolution Grid Scanning (right).**
