**Condition Assessments using Pipe Penetrating Radar:
the Metro Wastewater Reclamation District – Denver, CO
Harvard Gulch Interceptor Case Study**

Csaba Ékes, PhD, PGeo.¹ and Jeff Maier, P.E.²

This paper summarizes the application and results of the PPR technology through a pilot project conducted for Metro Wastewater Reclamation District in Denver, Colorado. The project took place in October 2011 on MWRD's Harvard Gulch Interceptor.

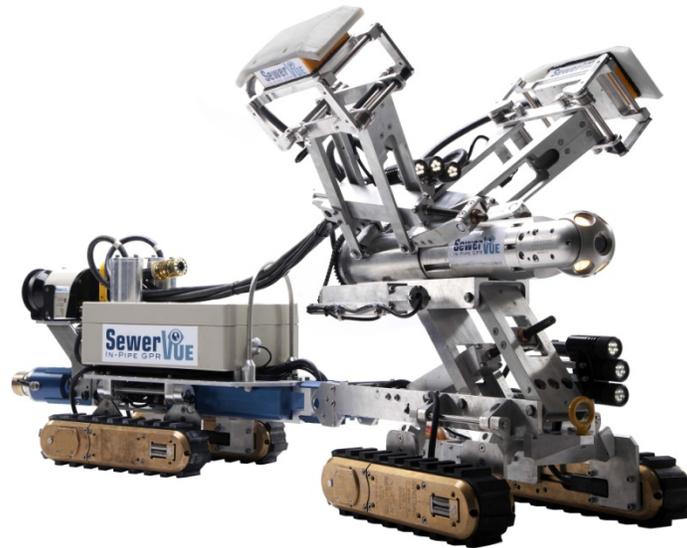
The SewerVUE Surveyor is the first commercially available multi-sensor inspection (MSI) robot that uses visual and quantitative technologies (CCTV, LIDAR, and PPR) to inspect underground pipes (Figure 1) (USEPA, 2010). This fourth generation PPR pipe inspection system is mounted on a rubber tracked robot and equipped with two high-frequency PPR antennae. The system used in Denver can be adjusted to accommodate 21 to 36-inch diameter pipes, and the PPR antennae can be rotated between the nine and three o'clock positions. Radar data collection is obtained via two independent channels in both in and out directions, providing a continuous reading on pipe wall thickness, rebar cover and locating voids outside the pipe. CCTV data is recorded simultaneously and is used for correlation with PPR data collection.

The robot is also outfitted with LIDAR capabilities to obtain quantitative measurements of inside pipe walls. This technology employs a rotating laser to collect inside pipe geometric data which is then used to determine pipe wall variances from a manufactured pipe specification. LIDAR data is correlated with an onboard inertial navigation system (INS) that can accurately map the x, y, and z coordinates of the pipe without the need for external references. The unit is equipped with three cameras (front, antenna and back).

Figure 1. Fourth generation multi-sensor inspection robot equipped with pan, tilt, zoom CCTV, LIDAR, and pipe penetrating radar.

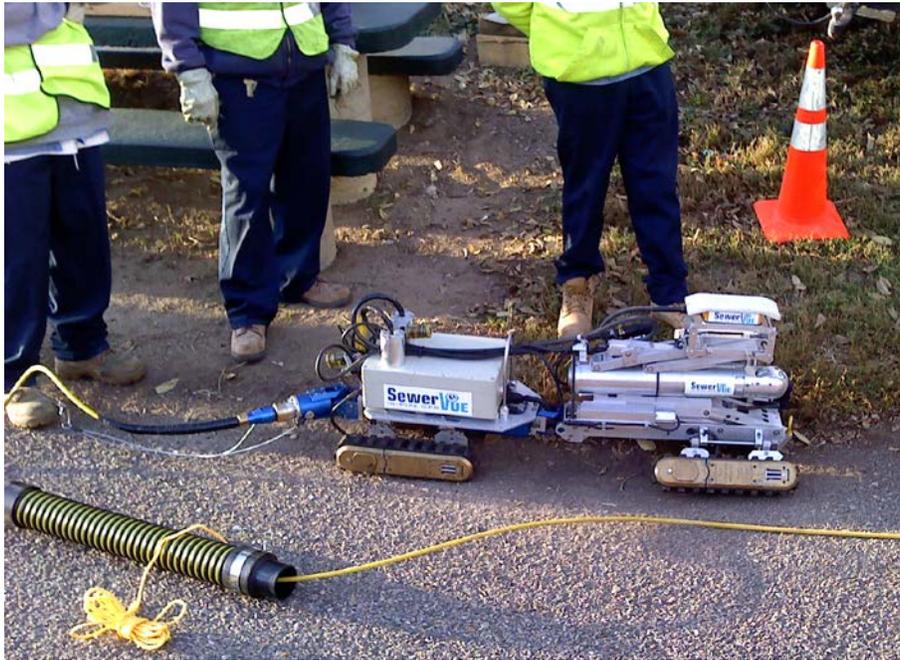
This project's PPR survey was completed using 1.6 and 2.3 GHz frequency antennas (Figure 3). 2D line data was collected on the springline and along the obvert of the pipe. The PPR lines were located along the 9:00, 10:30, 12:00, 1:00 and 3:00 o'clock positions inside the pipe.

Figure 3. Metro Wastewater O & M personnel readying the SewerVUE Surveyor robot for deployment at Harvard Gulch Interceptor, Denver, CO.
