Advanced Condition Assessment

For better Decision Making

Pipe Penetrating Radar (PPR)

The Salmon Creek and St John's Creek Interceptors, Vancouver, WA

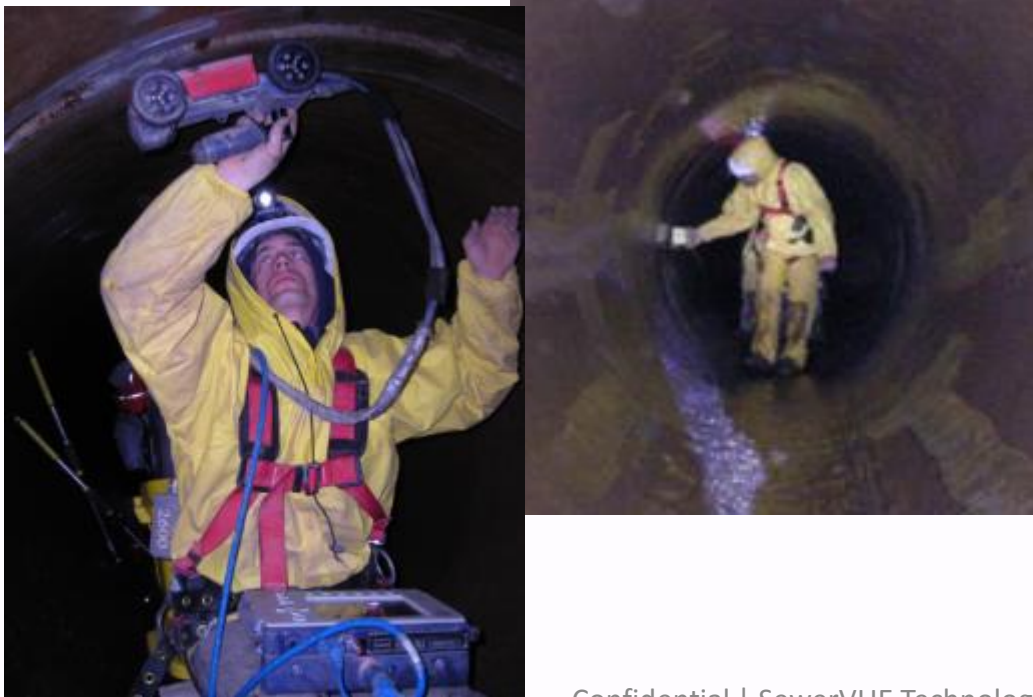
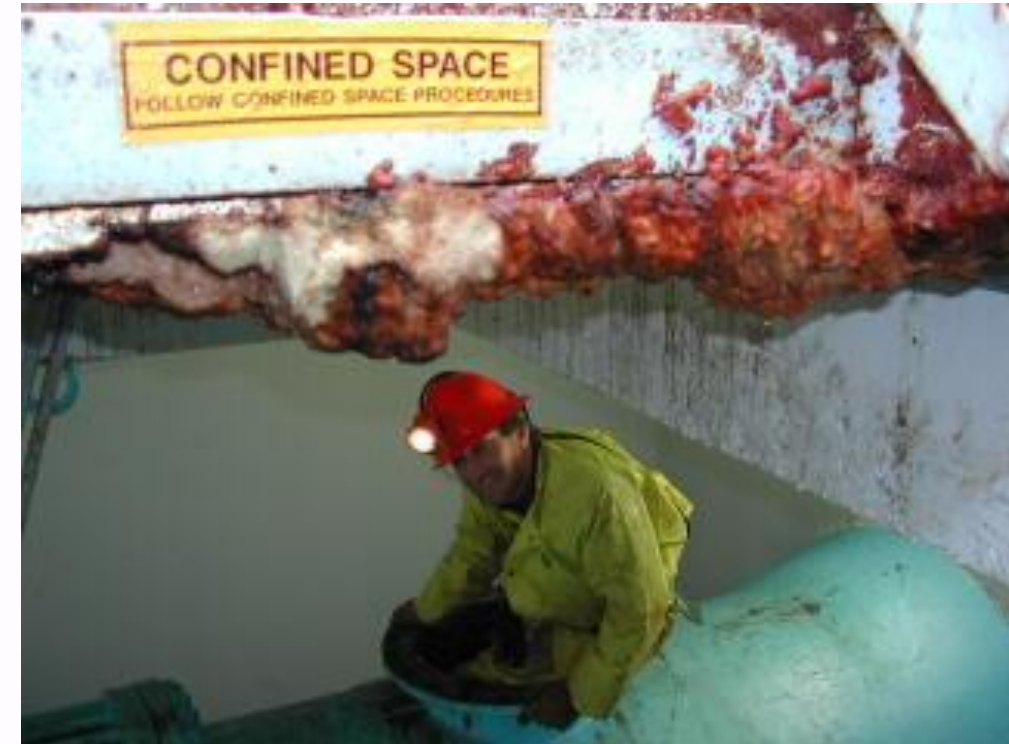
Manned Entry

Used for:

Large diameter water pipes

Where manned entry is safe

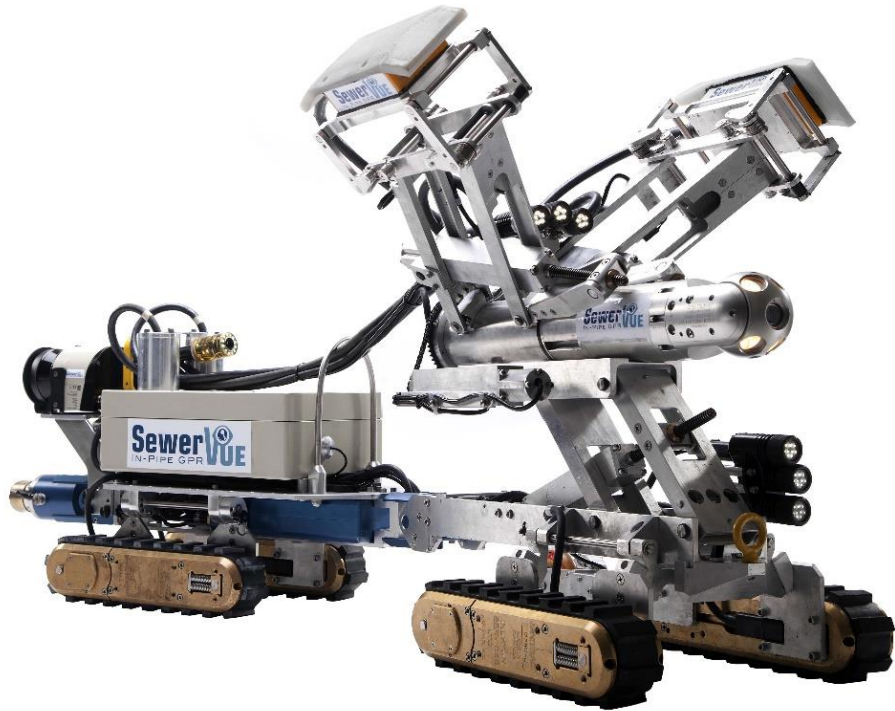
Generation Surveyor

Capabilities

- “Swiss army knife”
- 21-60 inch, (520-1500 mm)
- 6000 ft deployment capability
- 30 ft/min inspection speed

Specifications

- High frequency PPR antennae
- 3D LIDAR scanner
- HD CCTV (pan, tilt, zoom)
- Accurate x,y,z coordinates

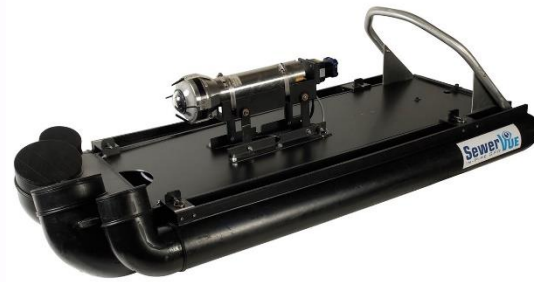
MPIS Float

Tethered ROV

CCTV

- HD Pan, Tilt, Zoom

LiDAR

- Point cloud, sub-mm profiling.

Sonar

- Sediment volume, below flow profiling.

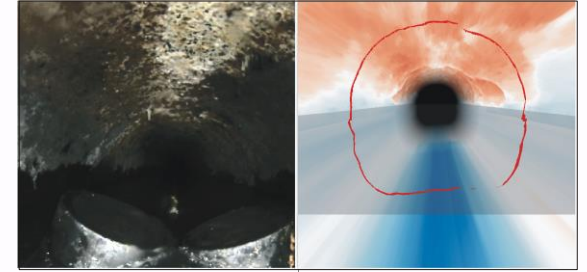
Varied pipe loss

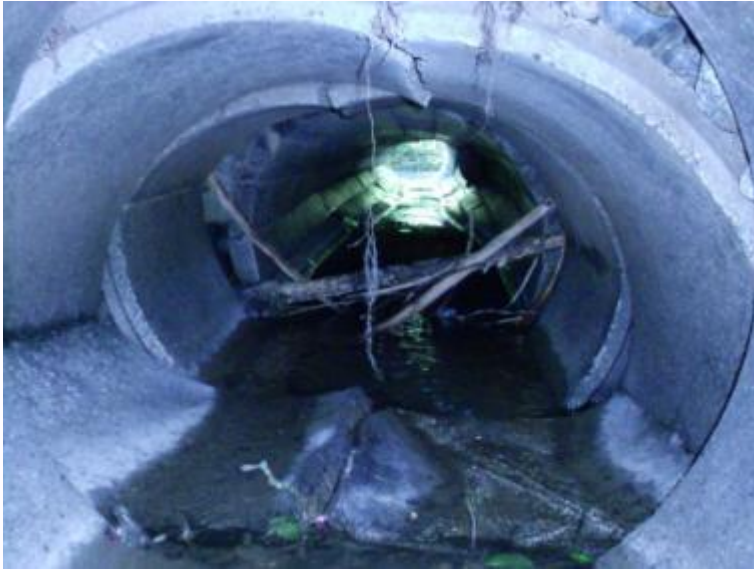
MH1 – MH2

Capabilities of MPIS Float

- Measure 90yr old wood stave pipe
- Must precisely measure pipe for CIPP liner

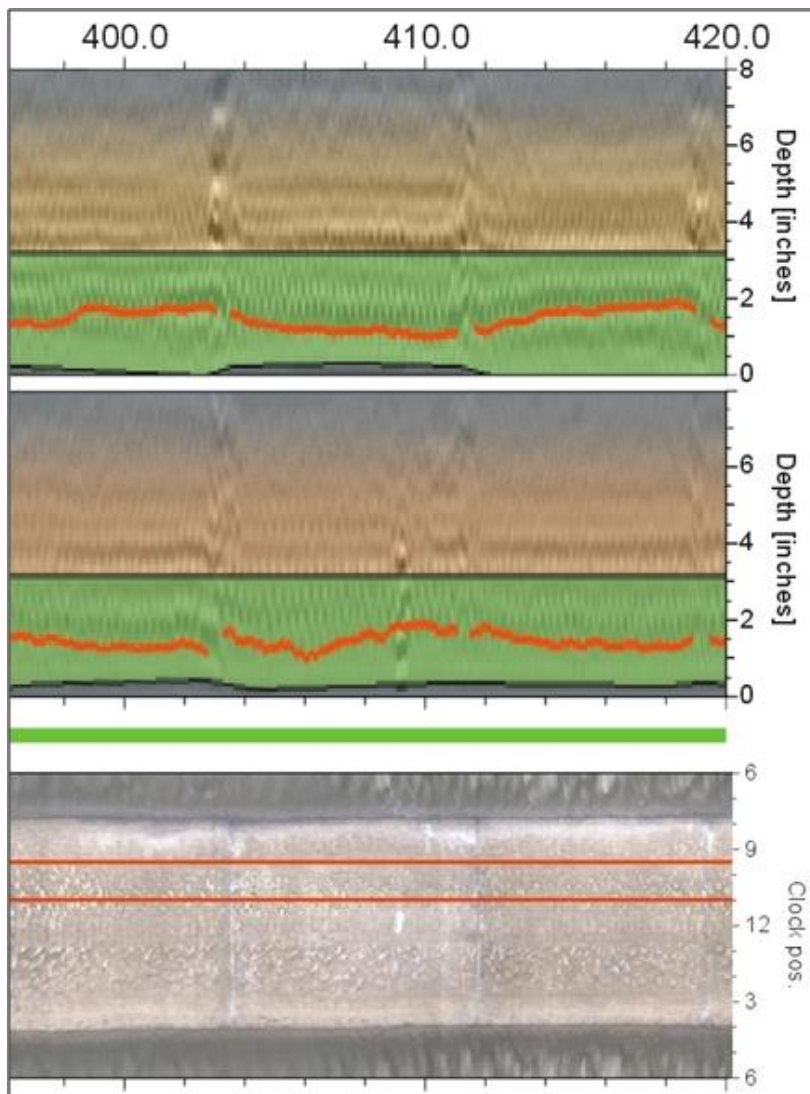
Depth Verification
